## Statistics of Bearing Failure and How it looks like For Failure Due to Electrical erosion

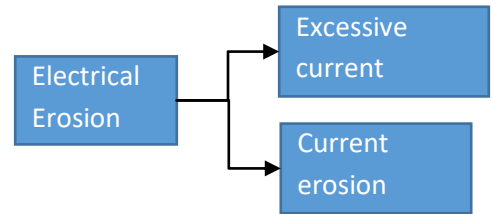
The Electrical Erosion is classified in to two as shown in the fig.

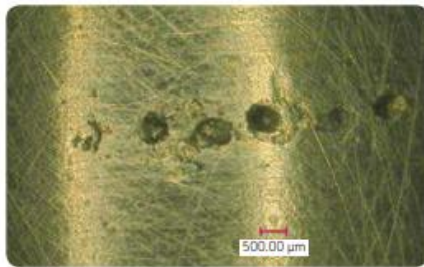
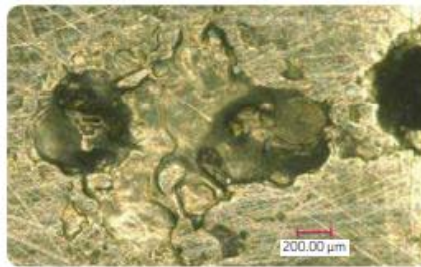
Craters of 0,5 mm in size

Magnification

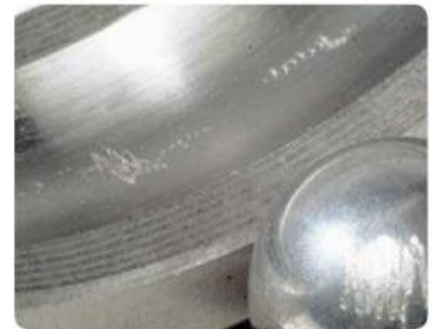
Fig shows damage caused by excessive electrical current in a deep groove ball bearing, both on the outer ring raceway and ball. Notice the zigzag burns. Excessive current erosion on the roller of a spherical roller bearing.

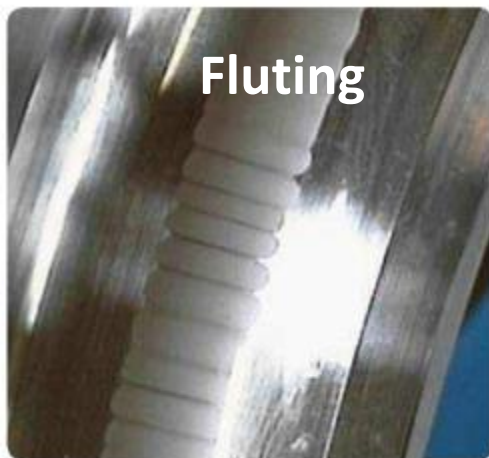
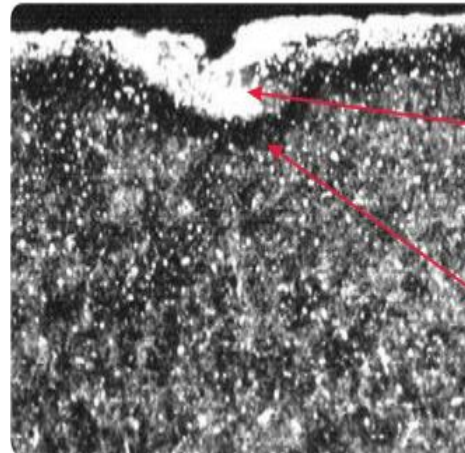
Fig. shows damage to a cylindrical roller bearing due to current leakage called as fluting mark. Washboarding is developing on the raceways and rollers. Notice the grease on the cage pockets. At the start of this failure mode, the grease is gradually carbonized and loses its ability to form a lubricant film. This eventually leads to surface-initiated fatigue, spalling and even sudden seizure.

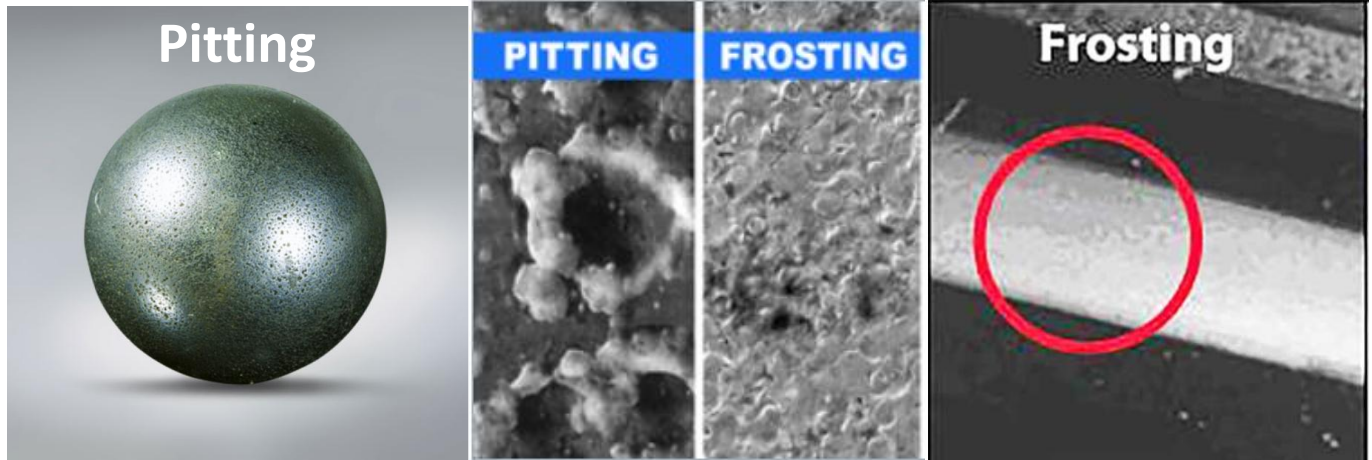
The fig shows two more type of damage called as pitting and frosting caused due to current erosion.
