Statistics of Bearing Failure and How it looks like For Failure Due to Electrical erosion

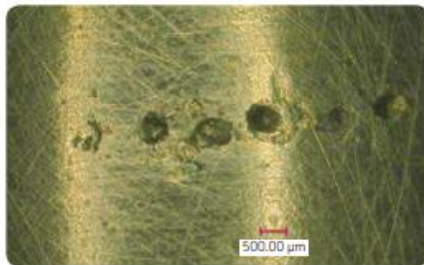
Craters of 0,5 mm in size

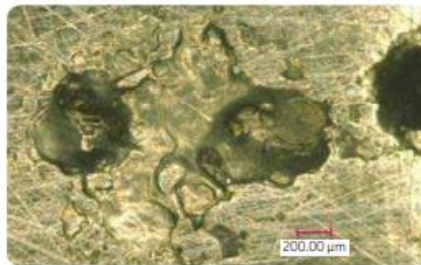
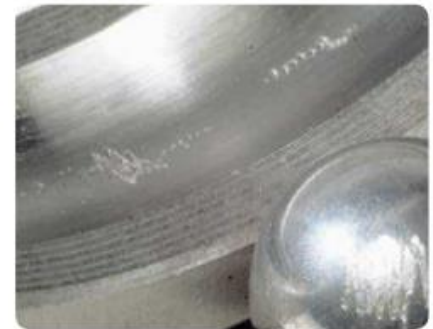
Magnification

Fig shows damage caused by excessive electrical current in a deep groove ball bearing, both on the outer ring raceway and ball. Notice the zigzag burns. Excessive current erosion on the roller of a spherical roller bearing.

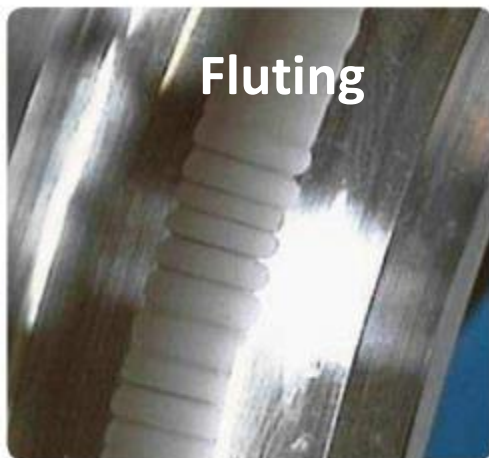
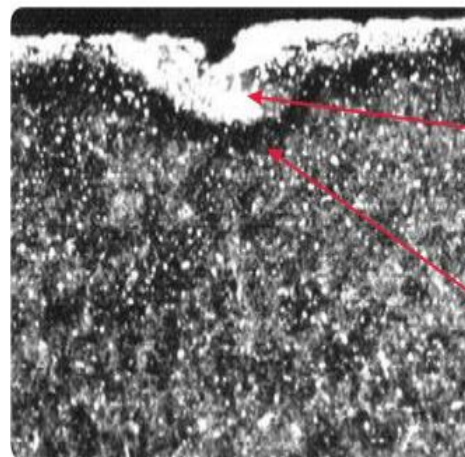
66 to 68 HRC

56 to 57 HRC

Fig. shows damage to a cylindrical roller bearing due to current leakage called as fluting mark. Wash boarding is developing on the raceways and rollers. Notice the grease on the cage pockets. At the start of this failure mode, the grease is gradually carbonized and loses its ability to form a lubricant film. This eventually leads to surface-initiated fatigue, spalling and even sudden seizure.

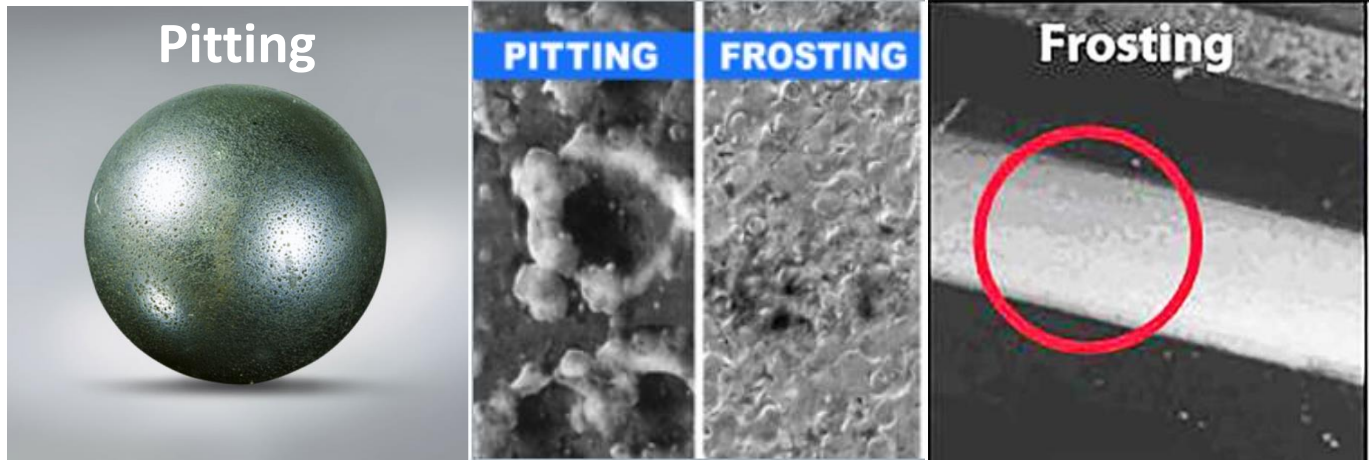
The fig shows two more type of damage called as pitting and frosting caused due to current erosion.
